Università degli Studi dell'Insubria

Ph.D. Thesis

***Use of Remote Sensing techniques for monitoring the impacts of  
ground movements on structures and infrastructure***

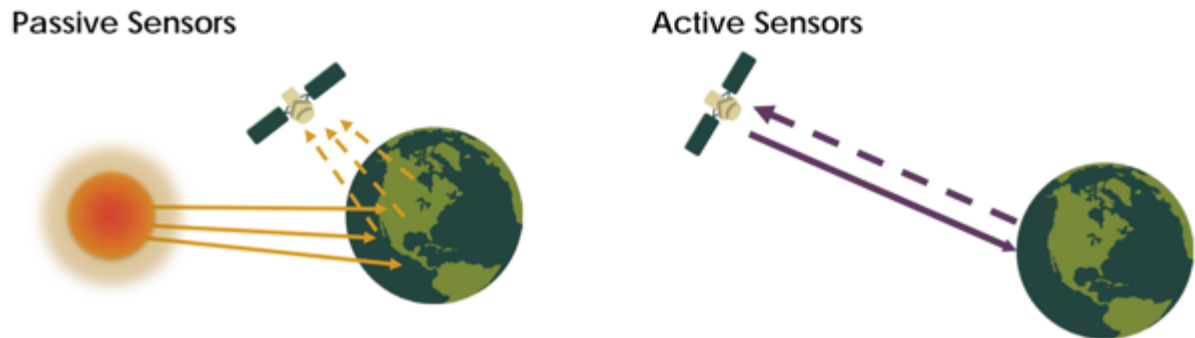
**Figure 2.1.** Schematic diagram of active and passive sensors mounted on satellites (credits: NASA Applied Remote Sensing Training Program; source: NASA, 2021).

Figure 2.1 shows the difference between satellites' active sensors (e.g., radar) that can acquire data in all-weather and night-and-day conditions, and passive sensors (e.g., optical) that depend on the weather and sunlight.

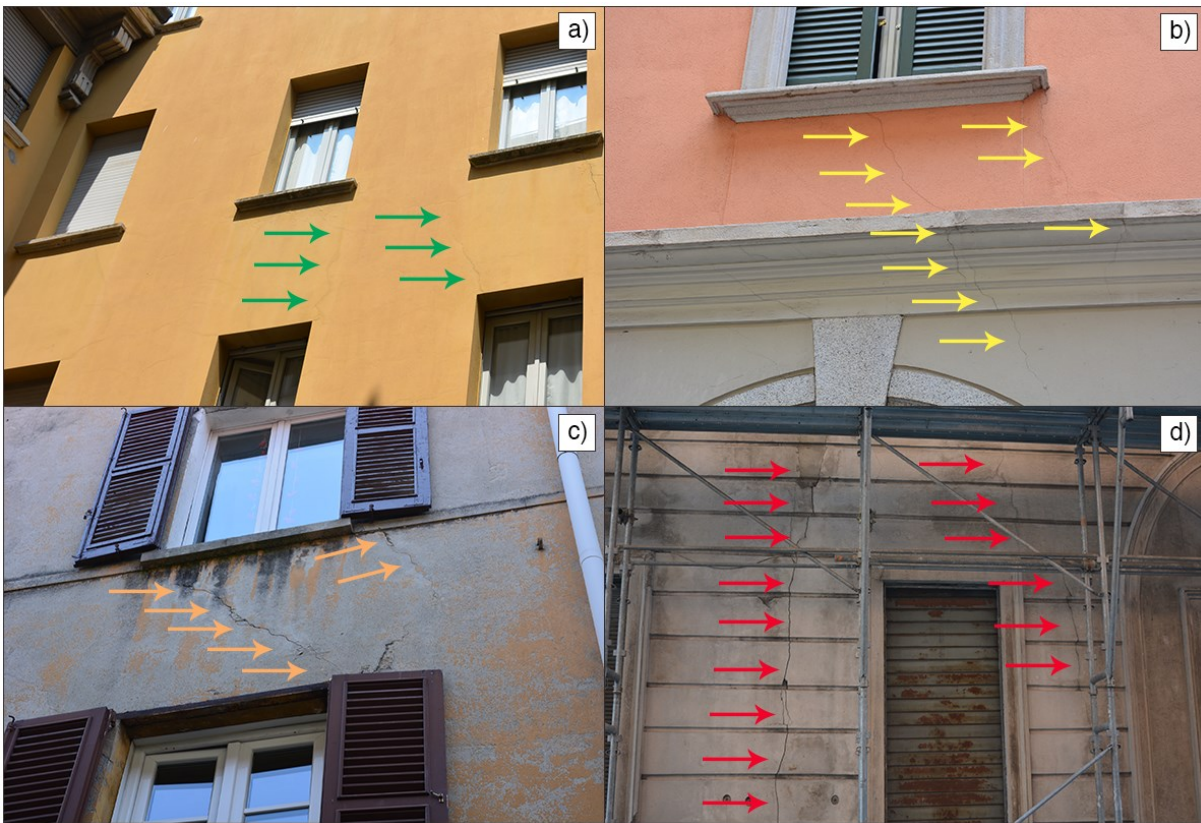
**Figure 3.5.** Modified from Nappo et al. (2021a). Building damage severity classification adapted from Burland et al. (1977): a) negligible ( $w < 0.1$  mm - D1); b) very slight ( $w < 1$  mm - D2); c) slight ( $w < 5$  mm - D3); d) moderate ( $w > 5$  mm - D4). Field investigations were performed in June 2019.

Field investigations in the historic centre of Como were performed in June 2019 to evaluate the typology, geometry, location and aperture of fractures affecting the buildings. The classification of building damage severity was adapted from Burland et al. (1977), thus distinguishing negligible ( $w < 0.1$  mm), very slight ( $w < 1$  mm), slight ( $w < 5$  mm) and moderate ( $w > 5$  mm) severity levels (Fig. 3.6), here respectively denominated as D1, D2, D3 and D4 (Nappo et al., 2021a).

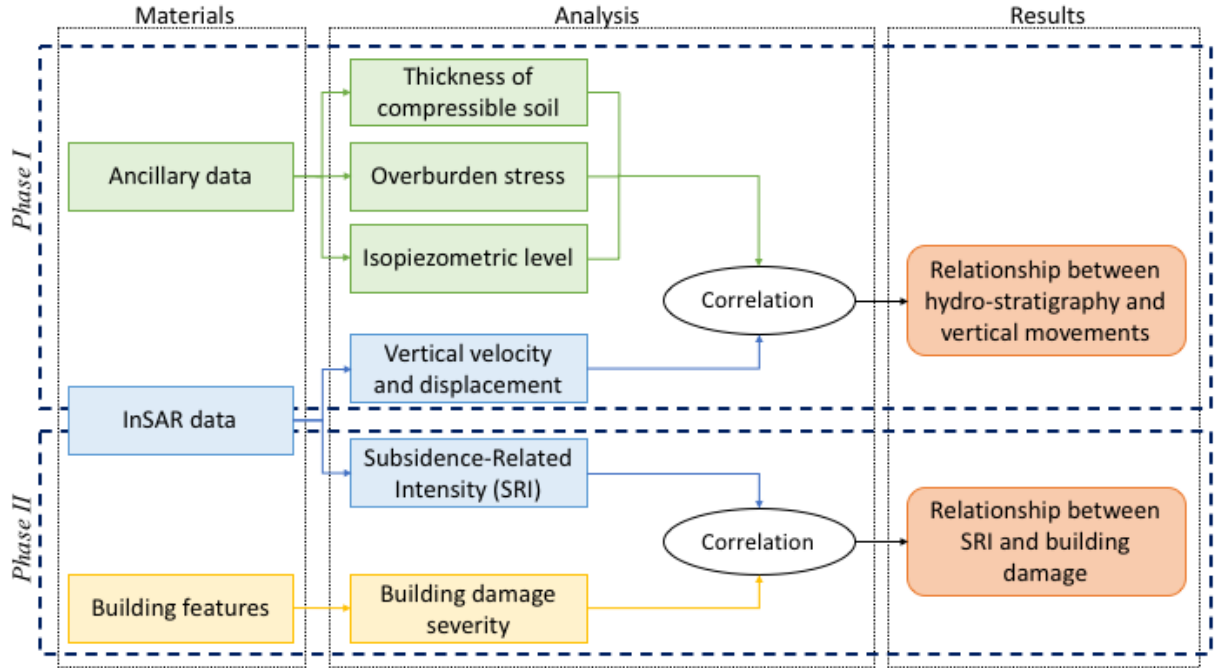
Figure 3.7. Modified from Nappo et al. (2020, 2021a). Schematic flowchart of the adopted methodology.

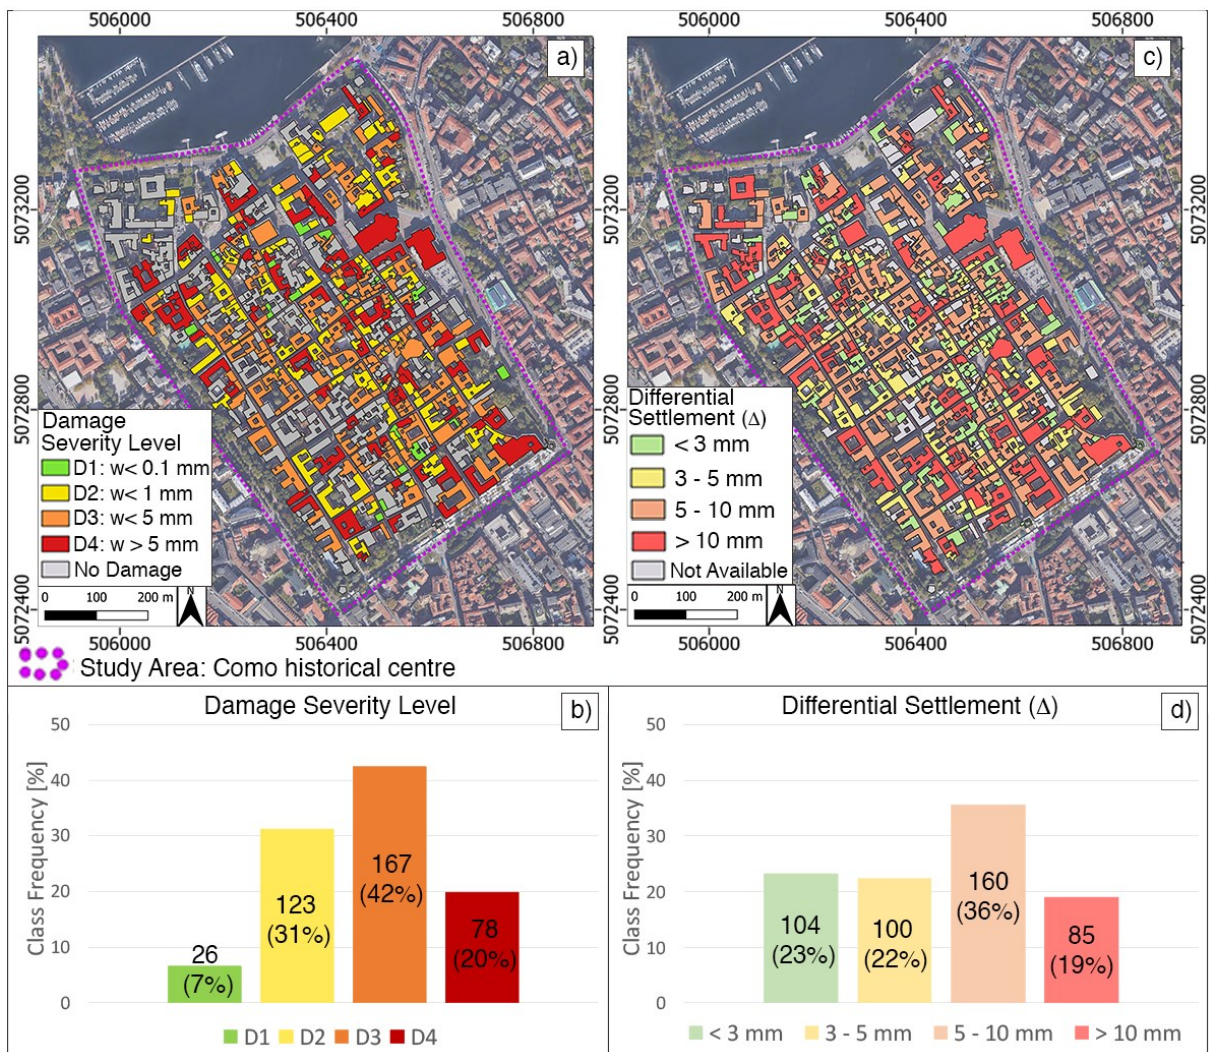
**Figure 3.9.** Modified from Nappo et al. (2021a). a) Map of building damage severity for the Como historic centre. b) Distribution of D1 – D4 severity levels for the 394 damaged buildings. c) Map of InSAR-derived differential settlement  $\Delta$  of buildings in the Como historic centre. d) Distribution of differential settlement classes (i.e.,  $\Delta < 3$  mm,  $3 < \Delta < 5$  mm,  $5 < \Delta < 10$  mm, and  $\Delta > 10$  mm) for the 449 buildings with not-negligible  $\Delta$ . Reference system: WGS84/UTM zone 32N.

topographic map had been overlaid with the CSK PS map and the subsidence-related intensity (SRI) parameters (i.e., differential settlement  $\Delta$  and relative rotation  $\theta$ ) computed via Equations 3.6, the surveyed buildings were classified also according to their  $\Delta$  values (Nappo et al., 2021a – Fig. 3.11c and d). With this classification, 75% of the buildings (i.e., 449 out of 600) showed non-negligible differential settlements, here distinguished in four classes:  $\Delta < 3$  mm,  $3 < \Delta < 5$  mm,  $5 < \Delta < 10$  mm, and  $\Delta > 10$  mm (Nappo et al., 2021a).

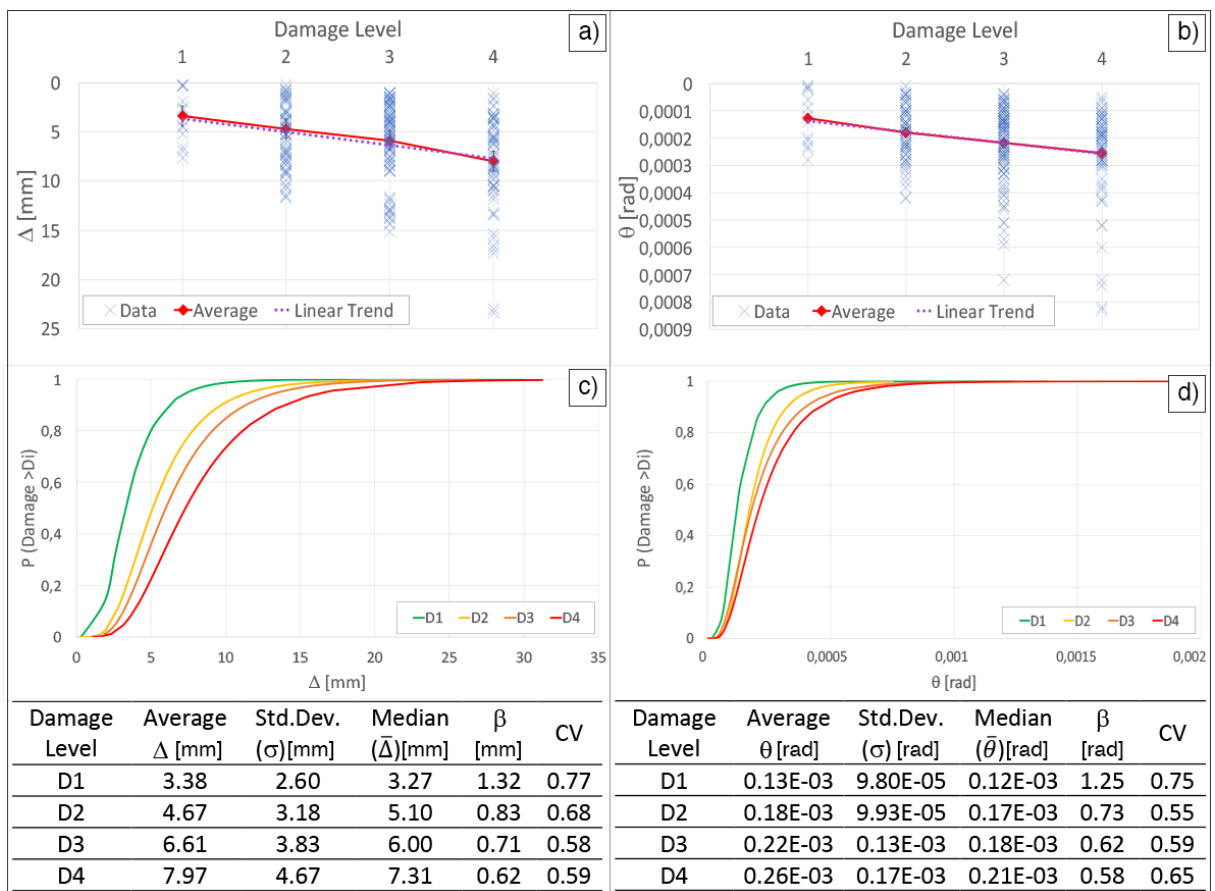
**Figure 3.10.** Modified from Nappo et al. (2021a). Vulnerability analysis of 275 masonry buildings in the Como historic centre. Correlation between damage severity levels and a) differential settlements ( $\Delta$ ) and b) relative rotation ( $\theta$ ). Fragility curves and parameters of Equation 3.1 computed for c) differential settlements ( $\Delta$ ) and d) relative rotation ( $\theta$ ).

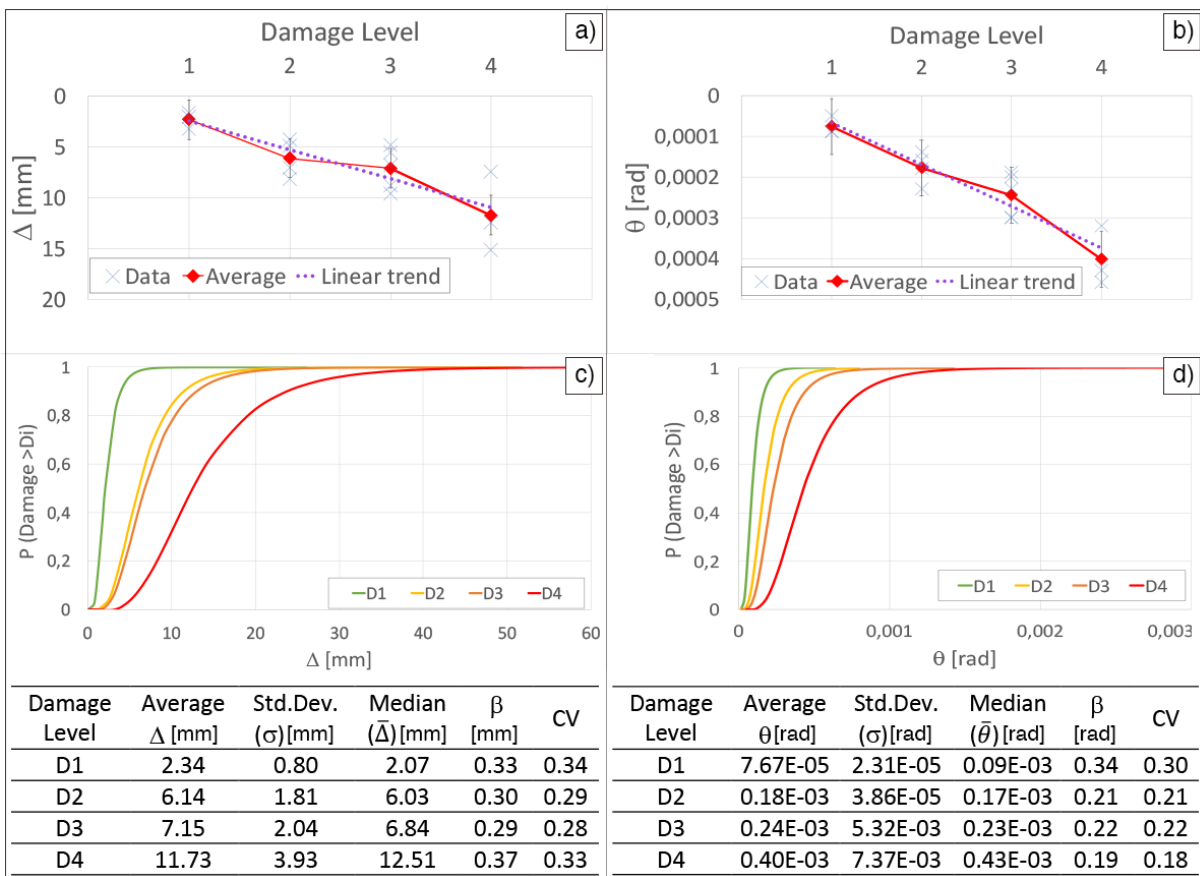
**Figure 3.11.** Modified from Nappo et al. (2021a). Vulnerability analysis of 15 reinforced concrete buildings in the Como historic centre. Correlation between damage levels and a) differential settlements ( $\Delta$ ) and b) relative rotation ( $\theta$ ). Fragility curves and parameters of Equation 3.1 computed for c) differential settlements ( $\Delta$ ) and d) relative rotation ( $\theta$ ).

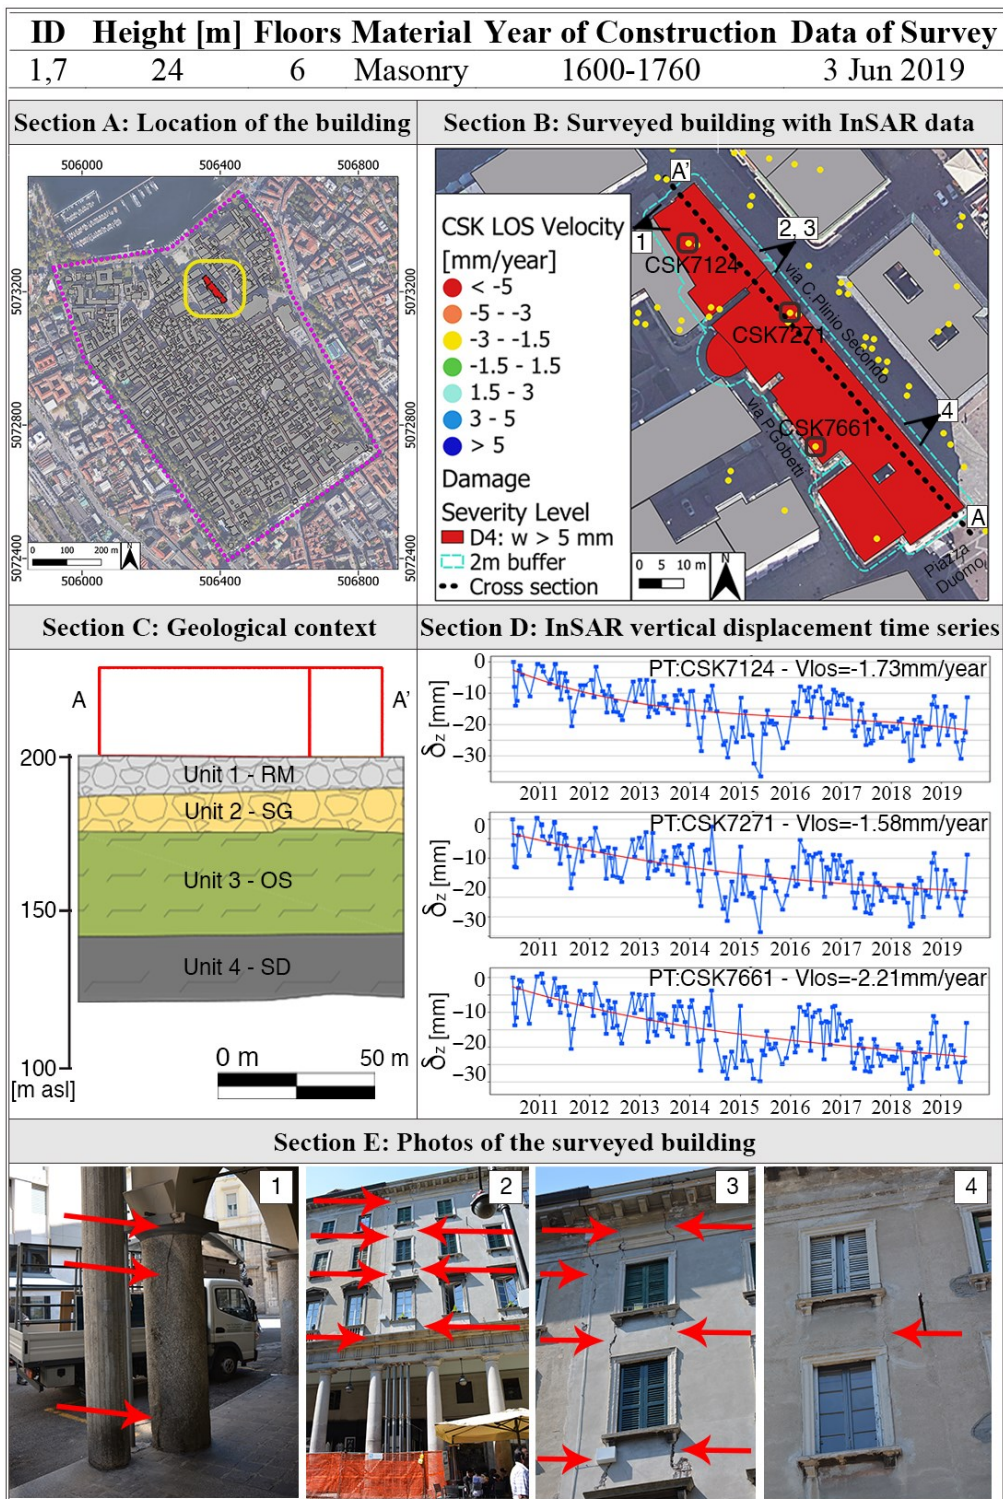
Figure 3.12. Modified from Nappo et al. (2021a). Example of factsheet (modified from Peduto et al., 2017c) to store the geolocation (Section A), a closer view with InSAR data and damage severity information (Section B), the geological context (Section C), the InSAR vertical displacement time series ( $\delta z$ ) (Section D), and some photos of the structural damage collected during the field survey (Section E) of buildings in the Como historic centre. Reference system: WGS84/UTM zone 32N.

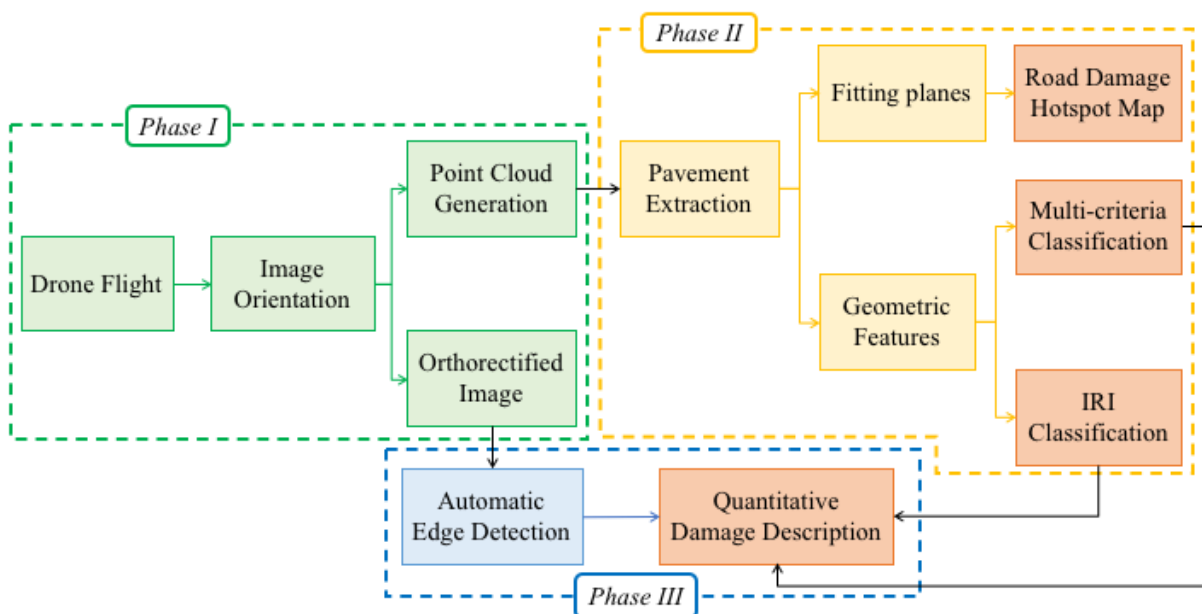
**Figure 4.3.** Modified from Nappo et al. (2021b). Flowchart of the proposed methodology.

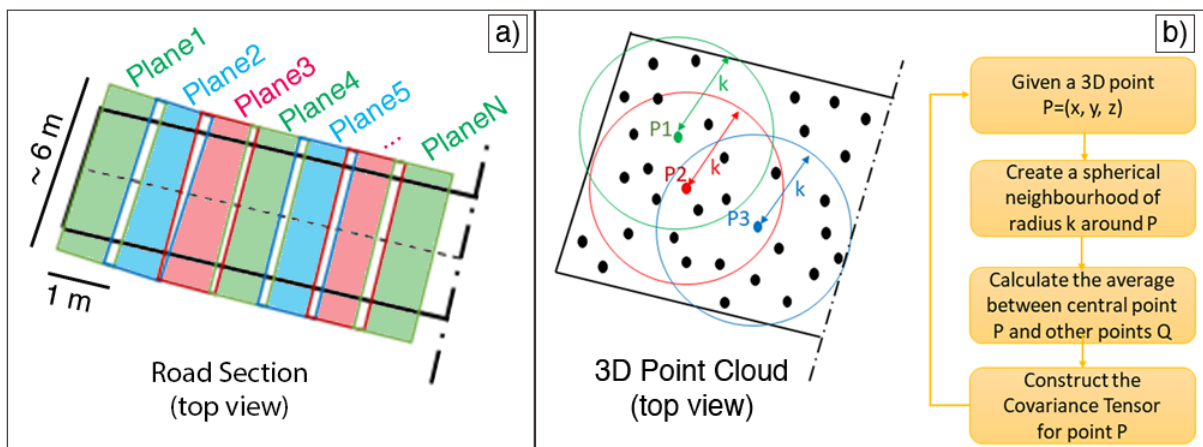
**Figure 4.4.** Modified from Nappo et al. (2021b). Processing schemes of Phase II. a) Set of planes progressively fitted to the road pavement and perpendicular to the road central line. b) Construction of spherical neighbourhoods around each 3D point and flowchart of the covariance matrix computation.

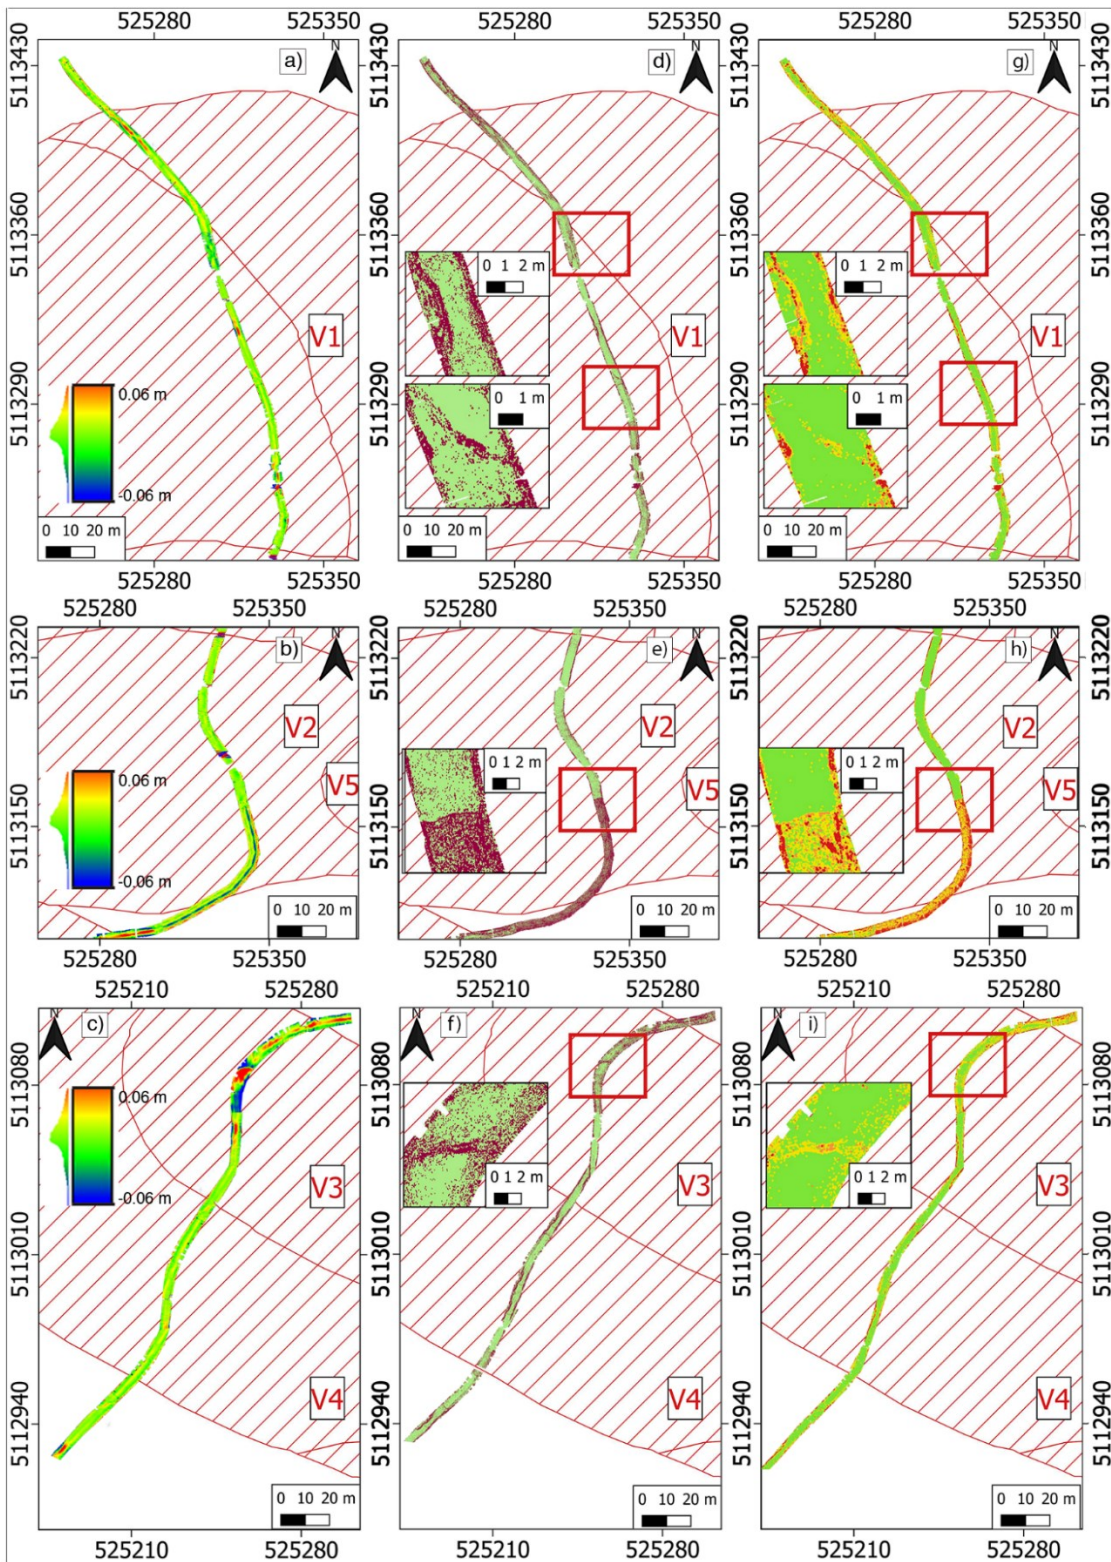
*Figure 4.14. Modified from Nappo et al. (2021b). Results for the SC – Vercana. a), b) and c) Road damage hotspot map. d), e) and f) Multi-criteria classification. g) h) and i) IRI-based severity classification. The road pavement crosses V1 slide in a), d) and g); the V2 slide in b), e) and h); the V3 and V4 slides in c), f) and i). Reference system: WGS84/UTM zone 32N.*

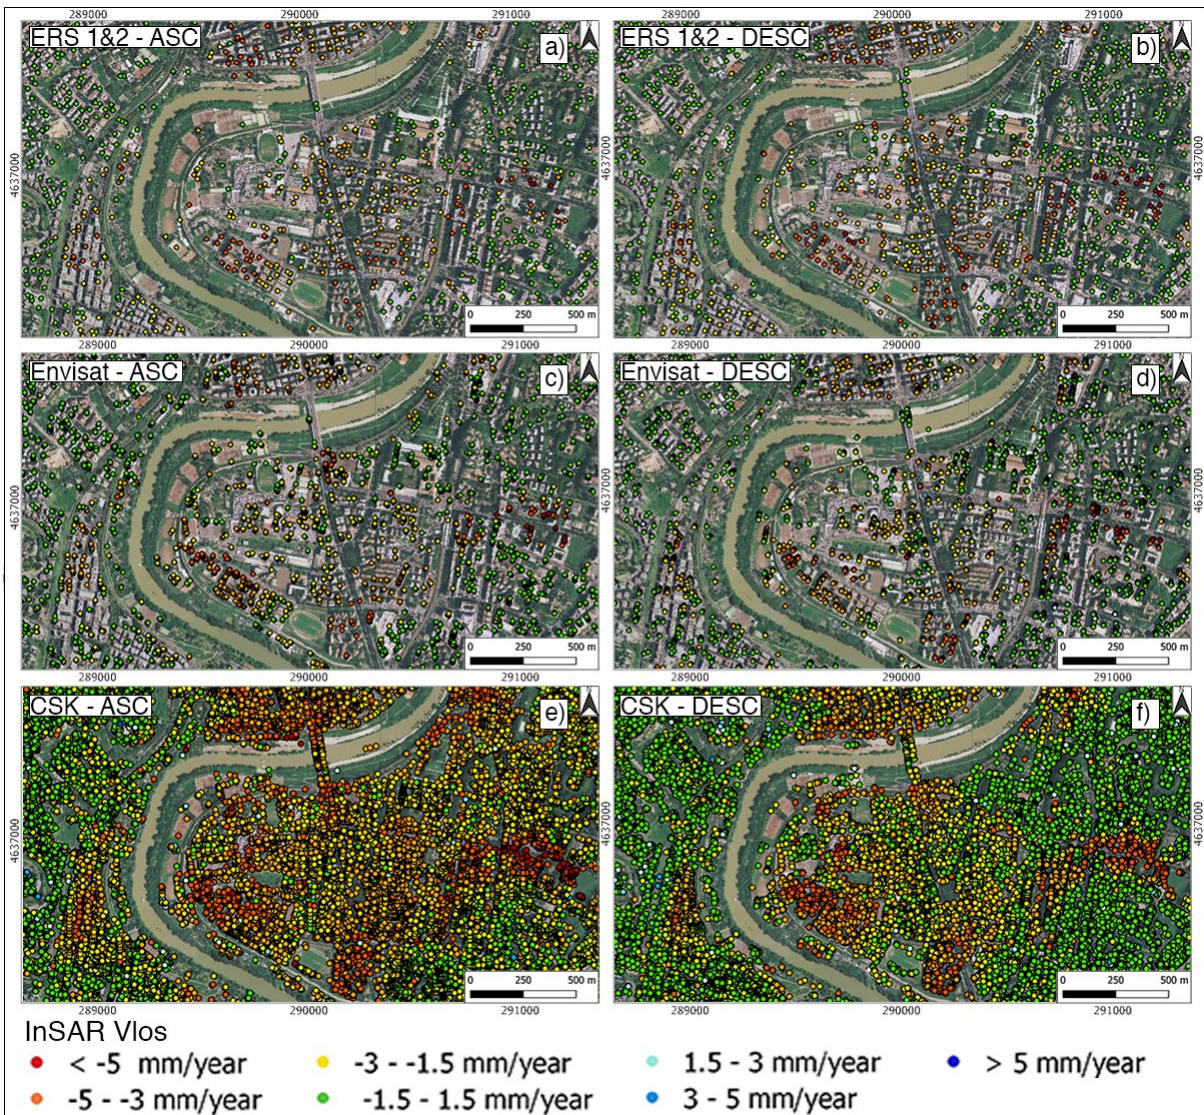
**Figure 5.2.** PS LOS velocity maps recorded from a) – b) ERS 1&2 (1992-2000), c) – d) Envisat (2003-2010), and e) – f) Cosmo-SkyMed (2011-2014), in ascending and descending acquisition geometries. (Source: Geoportale Nazionale, 2021). Reference system: WGS84/UTM zone 33N.

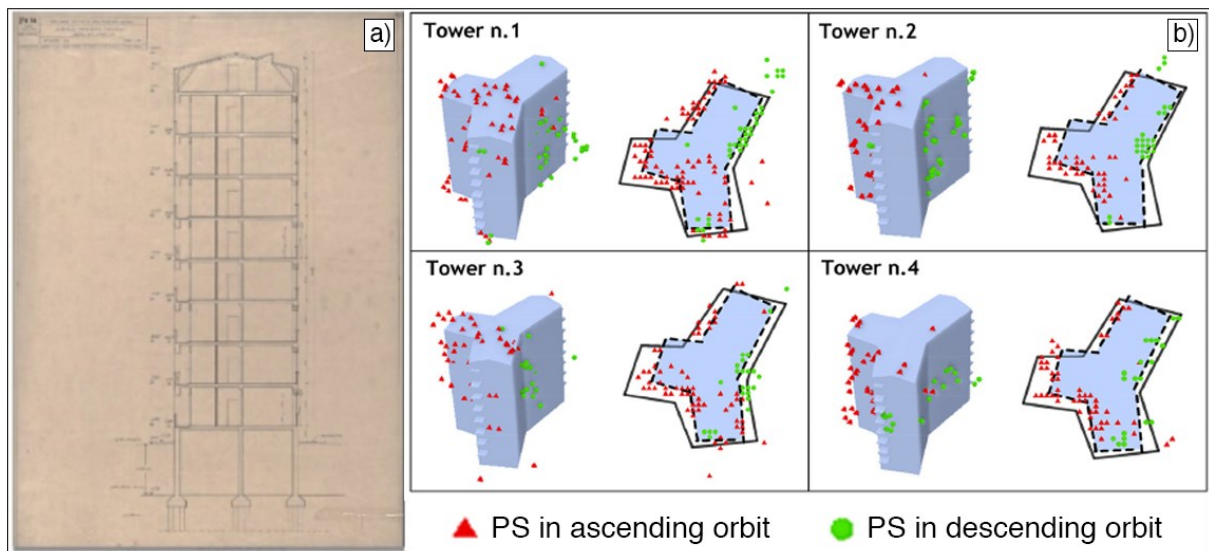
**Figure 5.3.** Example of tower buildings in Valco San Paolo residential area (Rome). a) Typical cross section of the buildings from archive records of the original construction project (modified from Di Carlo et al., 2021). b) Positioning of CSK PS in ascending and descending acquisition geometries on the 3D modelled buildings (modified from Di Carlo et al., 2021).
