Ground effects of the 18 October 1992, Murindo earthquake (NW Colombia), using the Environmental Seismic Intensity Scale (ESI 2007) for the assessment of intensity

S. Mosquera-Machado, C. Lalinde-Pulido, E. Salcedo-Hurtado and A. M. Michetti

Geological Society, London, Special Publications 2009; v. 316; p. 123-144
doi:10.1144/SP316.7

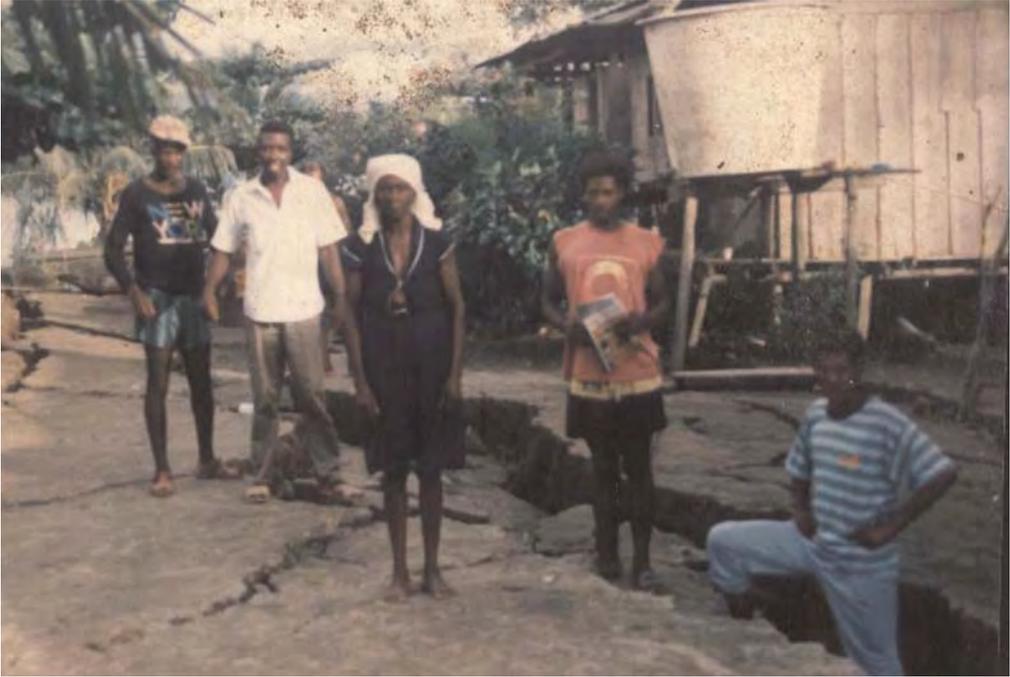
Ground cracks. Cracks were observed along the Atrato, Murindo and Jiguamiando rivers in the Atrato Medio Region from Quibdó to Murindo in a distance of 90 km (Fig. 7). They cut through soft young alluvial and loose material and vary in nature from place to place. They appear almost continuously, mainly parallel and perpendicular to the Atrato River, in lengths of a few metres up to 20 m. They varied in width from millimetres up to 1 m in Bojaya and Riosucio municipalities. To the west, ground cracks with millimetre opening have been reported as far away as Itmina, some 220 km SSW of the epicentre. To the east, these effects are observed only up to the surrounds of Medellín, about 130 km away from the epicentre. Cracks were observed also on the northern part of Atrato River in Turbo Municipality.

The distribution range of the ground cracks along the Atrato River varied from a few metres up to 30 m. Other ground cracks caused the loss of the river talus by creating small islands up to $5 \times 3 \text{ m}^2$, which floated in the river and finally disappeared helped by the torrential rain that followed the earthquake.

Fig. 7. Ground cracks induced by the Murindo events of October 1992 in Bojaya, (photo: S. Mosquera-Machado). For municipality locations, see Figure 3.

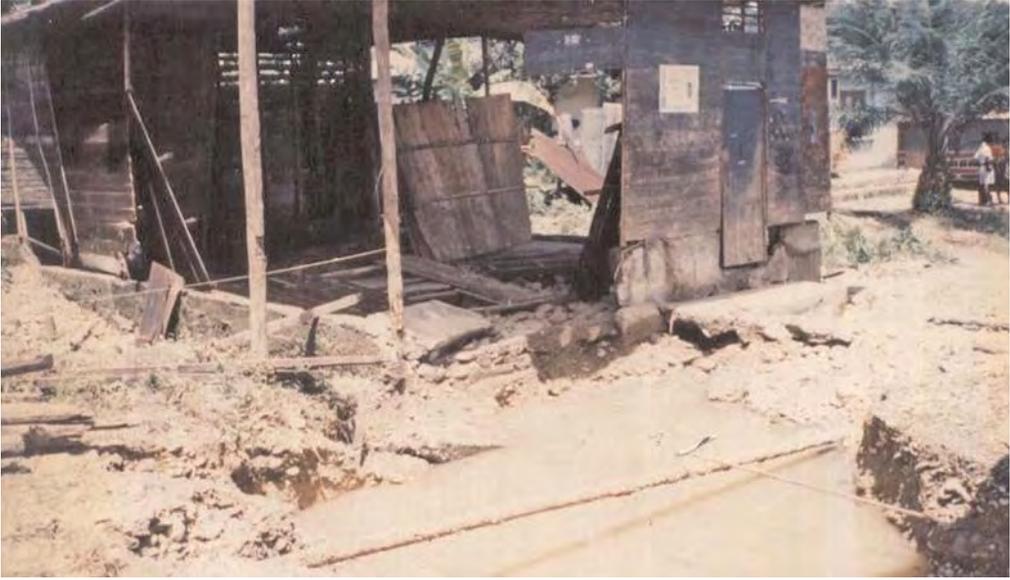
Vertical subsidence of 1.5 m was observed in la Grande (Rio Sucio) and 50 cm in San Jose de la Calle (Mosquera-Machado *et al.* 1992; Mosquera-Machado 1994b).

Fig. 10. Liquefaction with water upsurge in la Grande, Rio Sucio (photo: S. Mosquera-Machado).

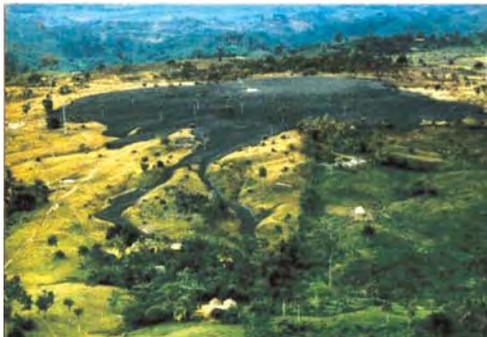
Murindo river channel; and the emergence of Damaquié Island near the Uraba Gulf. The Cacahual volcano erupted around 50 000 m³ of mud and sands (Fig. 13) followed by the ignition of gases that caused the death of seven people and injured 20 others (Fig. 14). The emergence of Damaquié

Fig. 13. Eruption of Cacahual mud volcano a few minutes after the 18 October 1992 Murindo earthquake (photo: E. Parra).

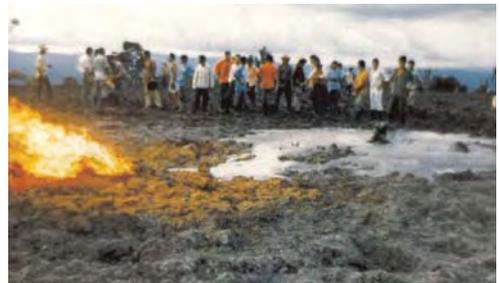
Fig. 14. Cacahual mud volcano fire followed by ignition of hydrocarbon and gas, a few minutes after the 18 October 1992 Murindo earthquake (photo: E. Parra).

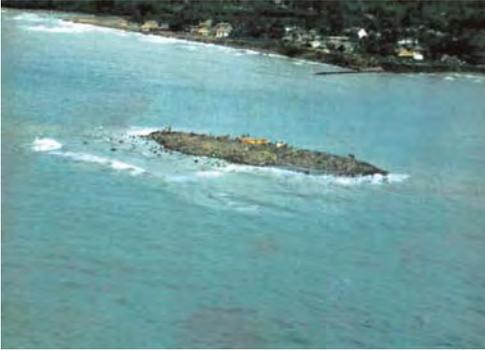
Island attracted our attention as a possible coseismic effect, although it appeared in the area periodically (each five to seven years) as reported by inhabitants (Fig. 15). Along the right bank of Murindo River in Murindo, the river shore gained around 10 m into the village. The change of channel direction may

Fig. 15. Damaquié Island emerged in the Gulf of Urabá after the 18 October 1992 Murindo earthquake (photo: E. Parra).
