The Cutaneous Microvascular Architecture of Human Diabetic Toe Studied by Corrosion Casting and Scanning Electron Microscopy Analysis

ABSTRACT

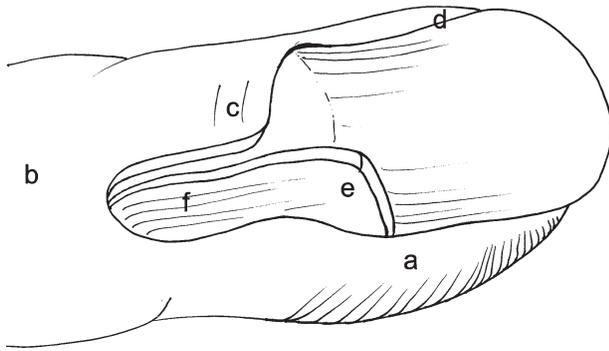
Scheme 1. Graphical representation of a human toe evidencing all the investigated areas: plantar side (a), dorsal side (b), eponychium (c), perionychium (d), nail bed (e), and nail root (f). Note that the nail and the skin of eponychium have been partially removed to allow a better visualization of nail bed and nail root.

graphical Scheme 1): plantar (a) and dorsal side (b) of toe skin, eponychium (c), perionychium (d), nail bed (e), and nail root (f).

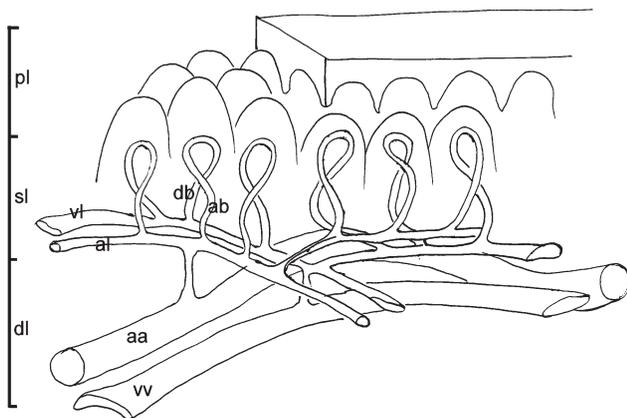
Scheme 2. Graphical representation of vascular layer constituting the human toe skin: dermal layer (dl), with big arteries (aa) and veins (vv); subpapillary layer (sl) characterized by arterioles (al) and venules (vl); papillary layer (pl) characterized by vascular villi made up of an ascending branch (ab) and a descending branch (db).

To be better oriented when looking at cutaneous microvasculature, we represented a graphical scheme (Scheme 2) evidencing:

- the dermal layer (d) with large-sized arteries (aa) and veins (vv) running freely in the dermal layer;
- the subpapillary layer (sl) characterized by arterioles (al) and venules (vl);
- the papillary layer (pl) characterized by vascular villi (vv) made up of an ascending branch (ab) arising from the arteriole and a descending branch (db) draining into a venule.

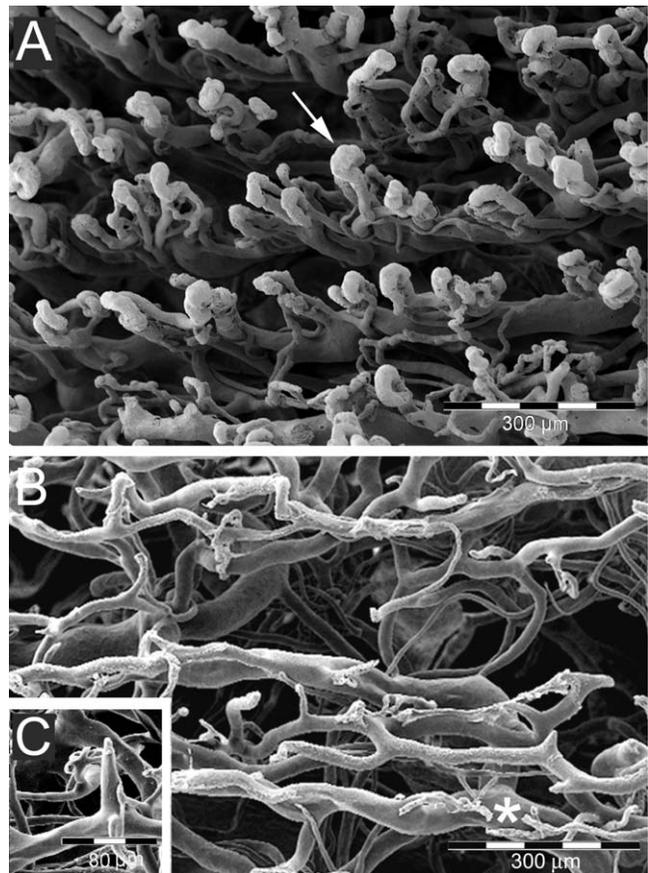
Fig. 1. Plantar side: (A) Normal toe: at low magnification it is possible to observe the two track-like disposition of subpapillary vessels giving rise to many vascular villi with dextrograte orientation (arrow). (B) Diabetic toe: note the absence of vascular villi (only the first ascending part is visible) and the normal microvascular structure of underlying vascular layers made up of medium-sized veins and arteries (*). (C) At high magnification, it is possible to better visualize the interrupted cast at the level of ascending branch of a vascular villi.

layer from which two track-like vessels originate that strictly follow the orientation of fingerprints (subpapillary layer) (Fig. 1). From these vessels, dextrograte vascular villi (consisting of an afferent ascending capillary and an efferent descending one) arise and enter each dermal papillae (papillary layer) (Fig. 1A). In the diabetic toes of patient (a), at low magnification it was already possible to observe an impairment of the shape and disposition of these vessels: the track-like dermal subpapillary vessels become more tortuous even if they seem to maintain the same orientation as the control (patient b) following the direction of fingerprints.

The vascular villi arising from the longitudinal vascular ridges are lost or highly damaged (Fig. 1B). Sometimes the ascending branch is visible ending with a “mouse tailed” or roundish tip, clear evidence of resin stop, probably due to vascular microthrombotic processes (Fig. 1C).

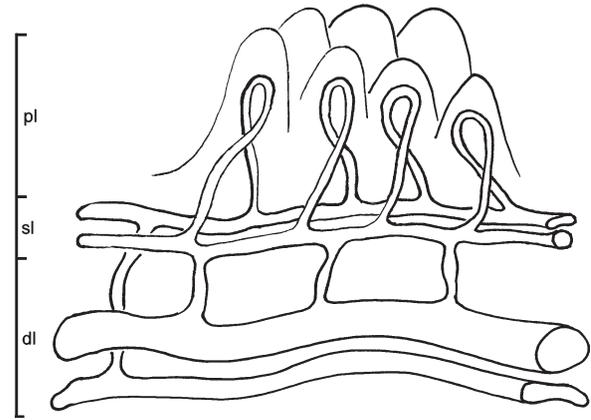
Scheme 3. Transverse section of toe normal skin: note the distribution of papillary (pl), subpapillary (sl), and dermal (dl) vessels.

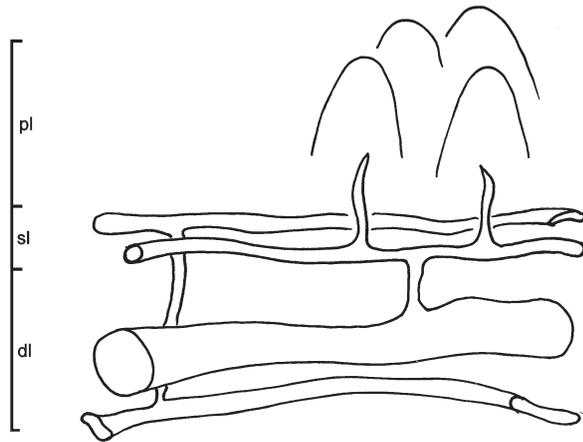
Scheme 4. Transverse section of toe diabetic skin: note the interruption of the ascending branch of vascular villi in papillary layer (pl) and the normal distribution of vessels in subpapillary (sl) and dermal (dl) layers.

constant direction of dermal subpapillary vessels because of the absence of fingerprints (Fig. 2A–C). The dextrorotate vascular villi arising from them are higher than those found in the plantar side, but they maintain the same direction, perpendicular to subpapillary layer, entering dermal papillae (Fig. 2A). In diabetic toes, these villi appear to be damaged and sometimes interrupted as in palmar side (Fig. 2B). Moreover, it was also possible to observe the loss of their efferent descending branch while the ascending branch is characterized, as already observed on the plantar side, by “mouse tailed” or roundish tips (Fig. 2C). To better distinguish the normal pattern of dermal microvasculature from the diabetic one, we made two graphical schemes simplifying what previously observed by SEM analysis of casts: in the first, we represented the normal distribution of dermal, subpapillary vessels and dermal villi seen in a transversal section (Scheme 3); in the second, the ascending capillary of vascular dermal villi is interrupted, whereas the subpapillary and dermal microvasculature is preserved (Scheme 4).

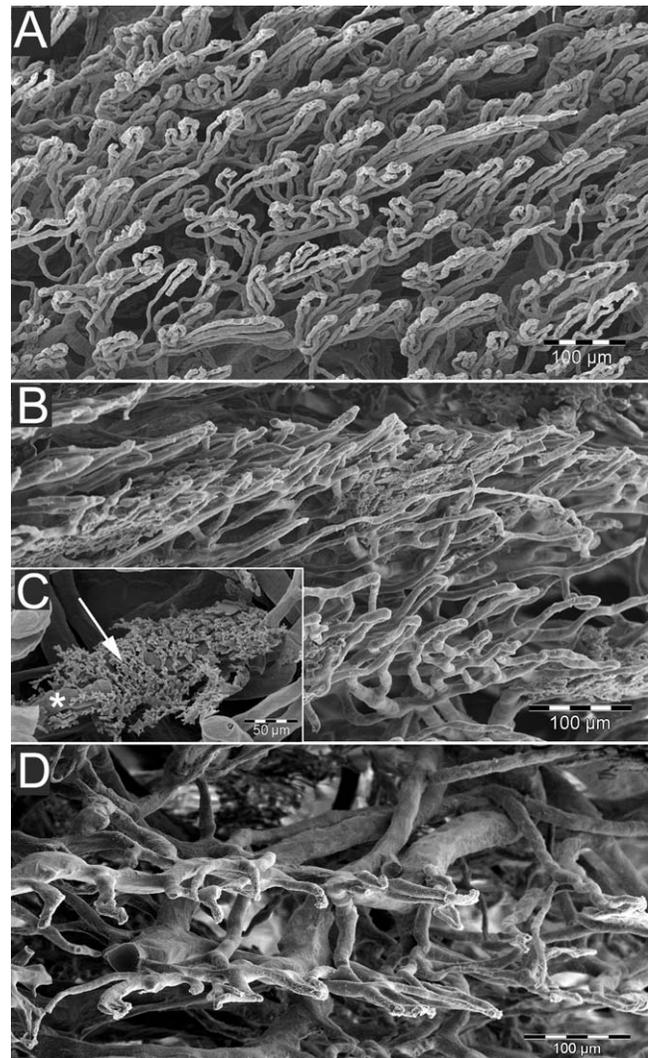
Fig. 3. Nail bed: (A) The normal disposition of vascular trabeculae made up of vascular villi entering the dermal papillae all oriented along the major axis of the digit. (B) Low magnifications of vascular trabeculae in diabetic toe: (C) note the presence of vascular leakages around capillaries and, at high magnification (arrow), (D) some interrupted vessels of vascular villi.

In the nail bed of normal toes, it is possible to see parallel vascular trabeculae directed along the major axis of the digit in the direction of the growing nail that follow dermal ridges (Fig. 3A). In the diabetic toes, the vascular trabeculae become more tortuous and convoluted (Fig. 3B). At high magnification, it is also possible to see clear signs of intercellular extravasations in the form of conglomerates or plastic sheets lying among the cast vessels (Fig. 3C). Sometimes it is also possible to see the incomplete filling of the resin in the trabeculae, which demonstrates the obliteration of the vessels (Fig. 3D).

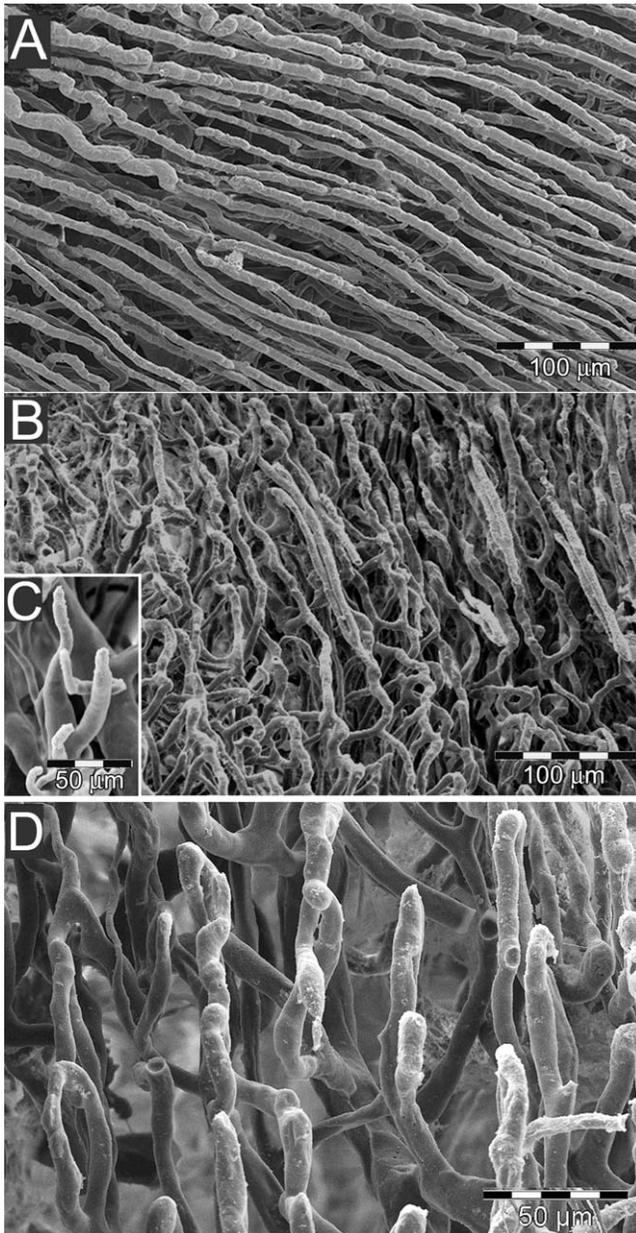
Fig. 4. Nail root (A): in the normal toe, the capillaries of the nail root are straight and directed along the major axis of the digit (arrow) and ending in the trabeculae of the nail bed previously described. (B) In the diabetic toe, the disposition seems to be more disorganized and present convolution of vessels. (C) Also, some sign of vascular obliteration are evident. (D) At high magnification, the dome-shaped sprouts visible in normal toe are no more distinguishable.

The microvascular architecture of the nail root in normal toes is made up of a dense net of longitudinal capillaries running toward the nail bed and gradually turning into their vascular trabeculae (Fig. 4A). At high magnification, it is also possible to observe some dome-shaped sprouts on the cast capillaries. In the diabetic toes, these vessels appear to be more tortuous and it is no longer possible to distinguish the dome-shaped sprouts (Fig. 4B,C).

Also, in the nail root, we could observe a modification both in the orientation and in the integrity of capillary vessels, which are probably signs of a reduction of capillary oxygenation and the consequent trophism of the nail, often observed in diabetic patients as nail morphological modifications. Moreover, the angiogenic sprouts found in the nail root of the normal toe are absent.

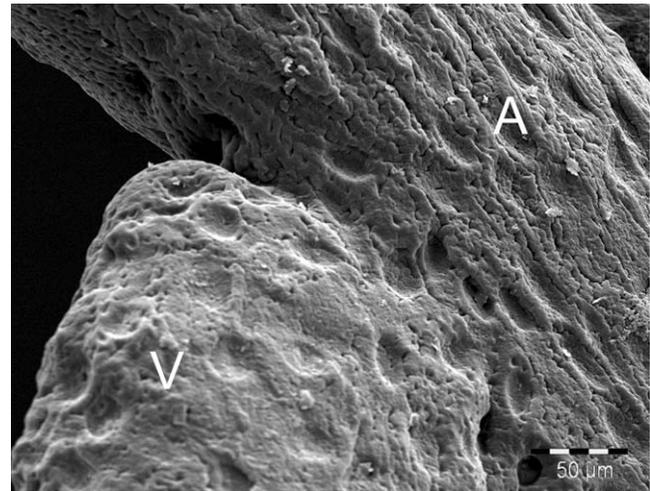
Fig. 5. Arteriovenous connection: note the disposition of the imprints of endothelial cell nuclei: on veins (V) they are arranged randomly along the vessels, whereas on arteries (A) they are placed along the major axis of the vessel. This difference enables us to distinguish arteries from veins and to demonstrate this end-to-side arteriovenous anastomosis.

Analyzing the subpapillary layer in all these areas, we could also observe some arteriovenous shunts either in the form of laterolateral or end-to-side arteriovenous anastomosis. It was also sometimes possible to observe extravasated conglomerates of resin in the form of sheets lying on the cast or spheroid bodies among them (Fig. 5).

In the dermal layer, it was also possible to observe some arteriovenous anastomoses that can be interpreted as signs of open collateral vascular circuits. This data, if confirmed by further investigations, could support the results obtained in the study of perfusion in diabetic foot microvessels *in vivo*: in the feet of patients with diabetic neuropathy, total skin blood flow has demonstrated to be increased because of a shunt flow mechanism.
